## REPORT ON INDUSTRIAL VISIT TO BUSDEPOT

Students of third year B.Tech, Mechanical along with three faculty members visited **TSRTC BUS DEPOT** on 24<sup>th</sup> Feb 2015. 56 students, day scholars and hostellers alike assembled at 9 am and left the campus in two buses that were arranged for the occasion. We reached our destination by 9.30 am where we were given a warm welcome.

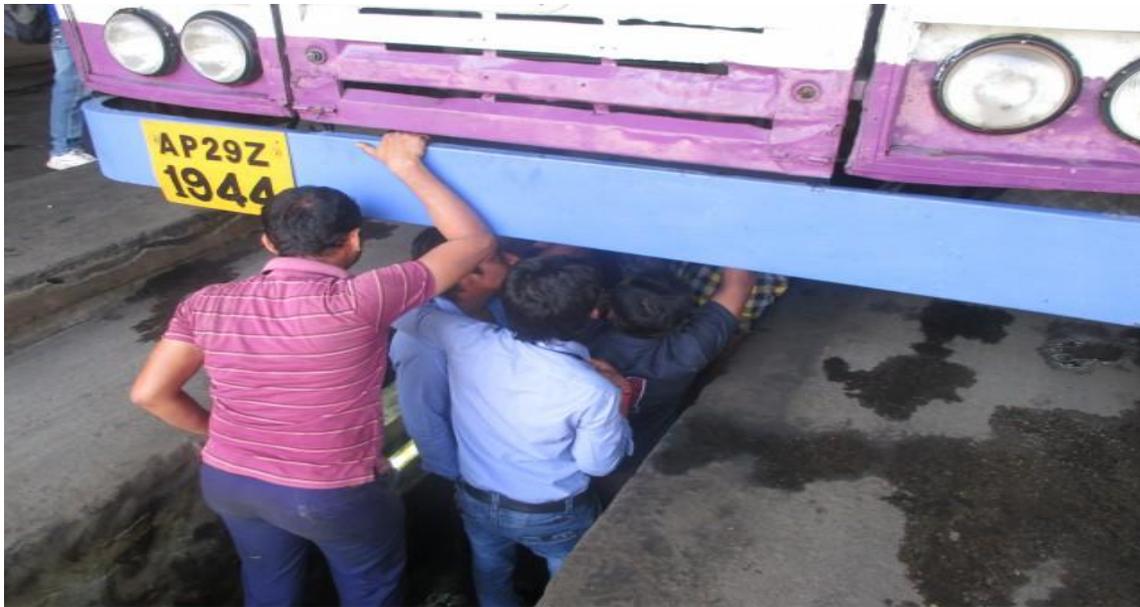
Overhauling Of Differential Each tooth is inspected minutely for any pitting or broken teeth on crown wheel pinion, sun and star pinion Checking the back lash of the sun pinion with a star pinion
